2012 Chevrolet Corvette | Corvette VIN Y Service Manual | Document ID: 2805055

#09-08-67-013C: Folding Top Contacts Stowage Compartment Lid (Tonneau) and/or Tonneau Contacts Rear Window During Top Operation (Verify Condition and Perform Appropriate Adjustments) - (Mar 21, 2012)

Models: 2005-2013 Chevrolet Corvette

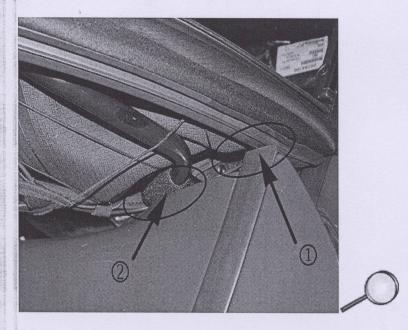
Condition #1

Some customers may comment that when opening/closing the folding top, the tonneau protector strip (1) is hitting the #5 bow seal or that the tonneau lid is hitting the #5 bow pressure link (2).

This condition may be caused by improper alignment of the folding top mechanism and/or tonneau lid.

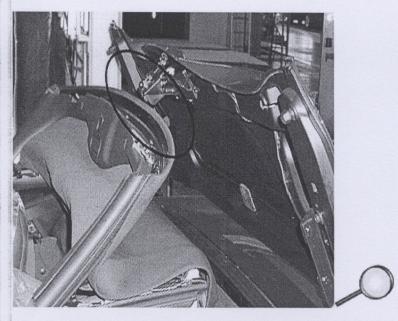
Condition #2

Some customers may comment that when opening/closing the folding top, the tonneau latch (circled above) is hitting the front edge of folding top #1 bow.
